Kotzebue Electric Association, Inc
 09/15/2010
 Quarterly Project Report

Wales Diesel-Off High Penetration Wind System

Kotzebue Electric Association

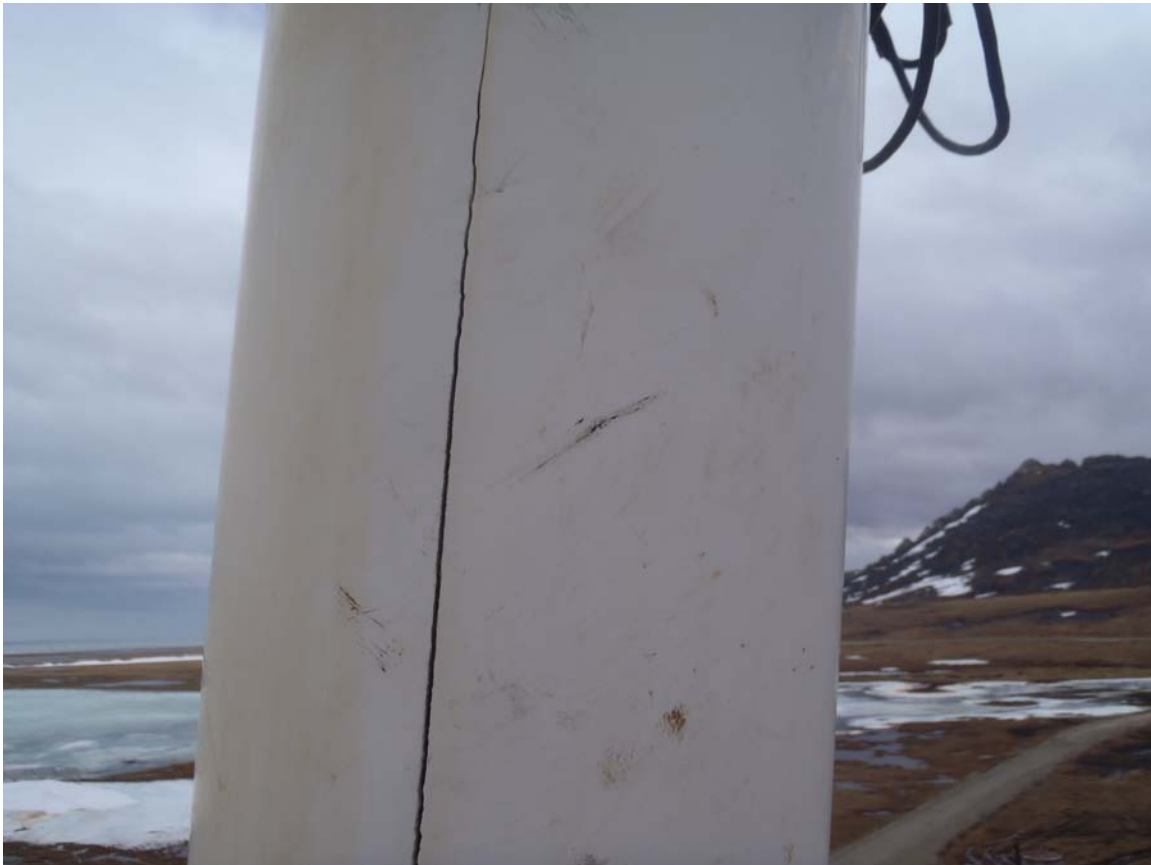
8. Blades structurally seem to be fine: bending without cracking noise, no rattling inside the cavity, however, there are surface cracks of concern.
 - a. Surface cracks were observed on all leading edges of the blades on Turbines 1 and 2.

- b. It seems the crack is indeed within the surface structure of the blade and could be repaired with epoxy on the next site visit.
 - c. Cracks were between 1 and 4.5 feet in length, and 1/16 of an inch at the widest point.

Picture 1: Blade Crack

As of September 2010 the Wales Diesel-Off High Penetration Wind System project is on budget. One change in the schedule is task 2.2 “Turbine Repair.” This is due in part to cracks in the turbine blades (see pictures) that need to be filled and repaired with epoxy. The epoxy is on order from the lower 48.

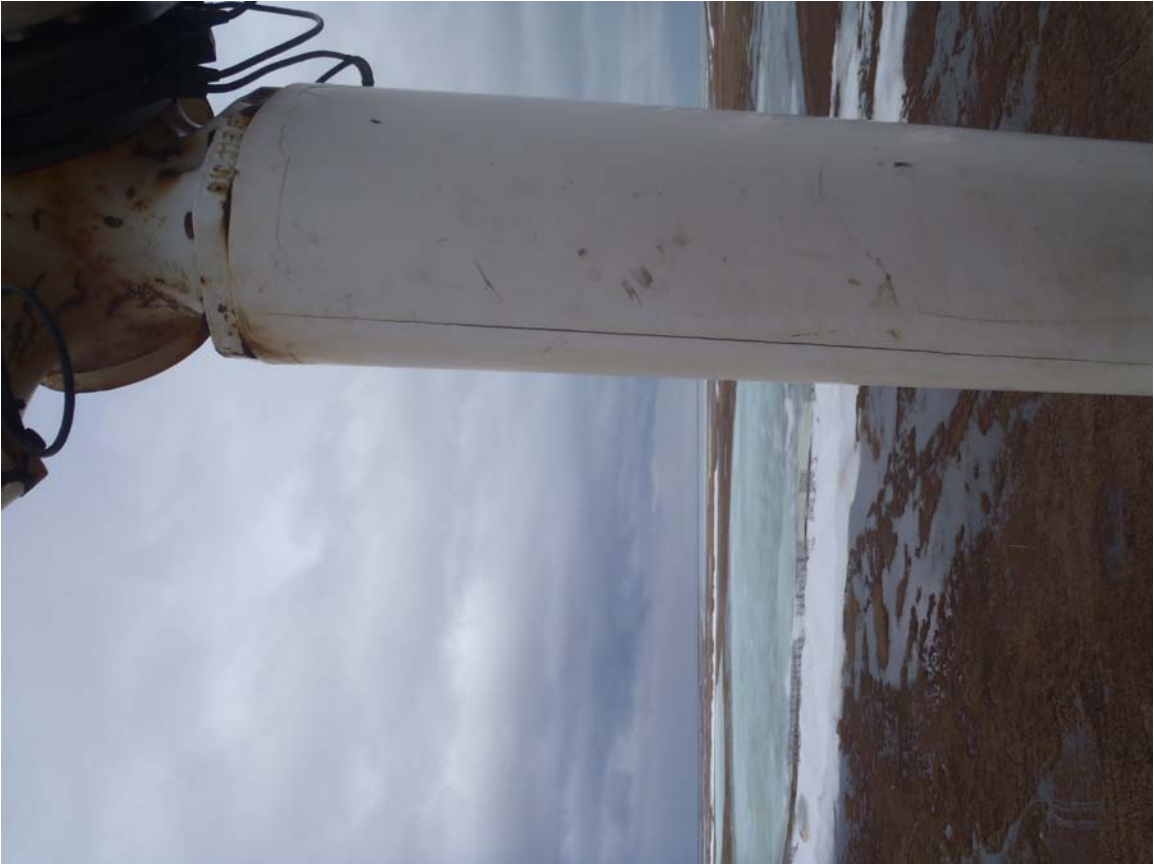
Picture 2: Blade Crack and Corrosion

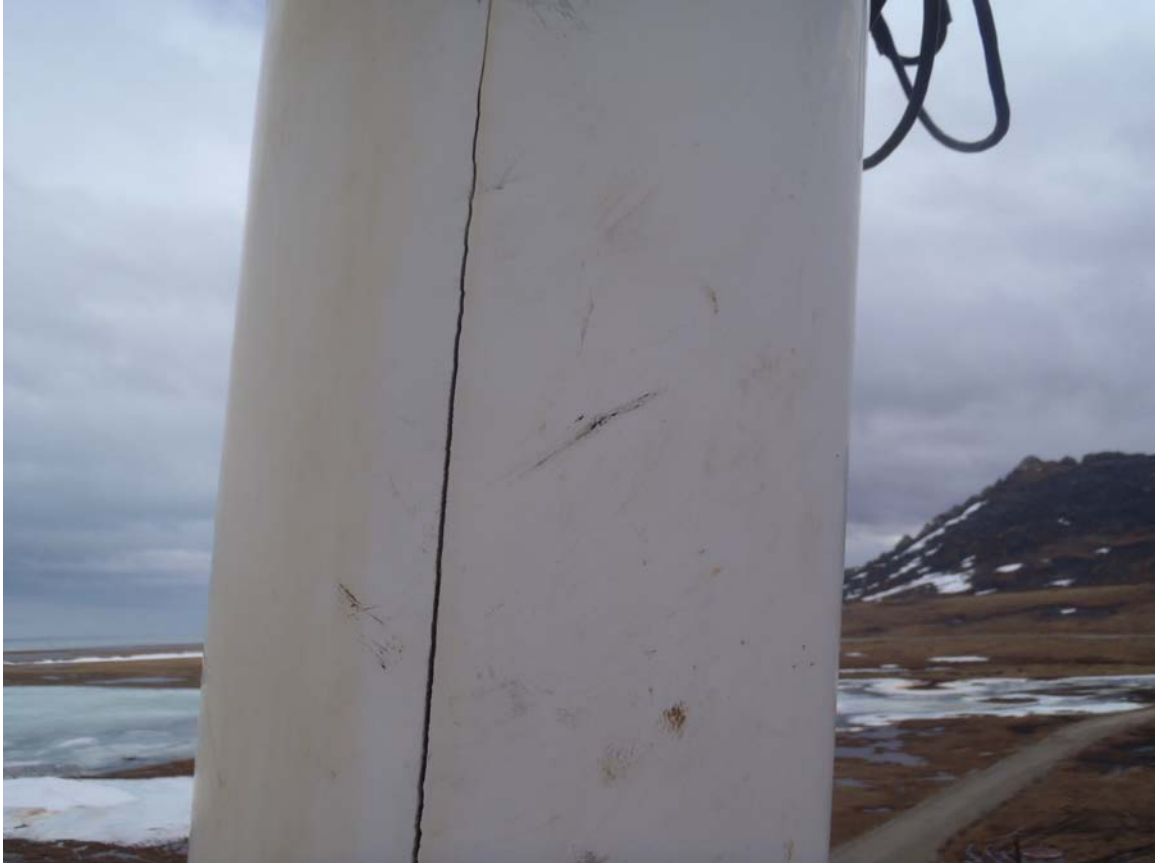
8. Blades structurally seem to be fine: bending without cracking noise, no rattling inside the cavity, however, there are surface cracks of concern.
 - a. Surface cracks were observed on all leading edges of the blades on Turbines 1 and 2.
 - b. It seems the crack is indeed within the surface structure of the blade and could be repaired with epoxy on the next site visit.
 - c. Cracks were between 1 and 4.5 feet in length, and 1/16 of an inch at the widest point.
 - d. Minor swelling was present in the end of the blade due to water buildup, which made the tip brakes fit very tight.
9. Generator was working correctly in both motor jog and connection states on both machines.
 - a. Phase rotation was verified
 - b. Correct Amperage in motor job and connection modes
 - c. Voltage was correct line-line and line-ground.

Picture 1: Blade Crack

Further operating tests need to take place, but the blade cracks currently prevent this. The epoxy was shipped to Western Community in September, but they did not schedule a trip into Wales which will delay the entire project. Severe weather and cold temperatures in will prevent a trip to repair the blades until sometime in the spring of 2011. Repair of the blades will be critical to safe operation of the wind turbines.

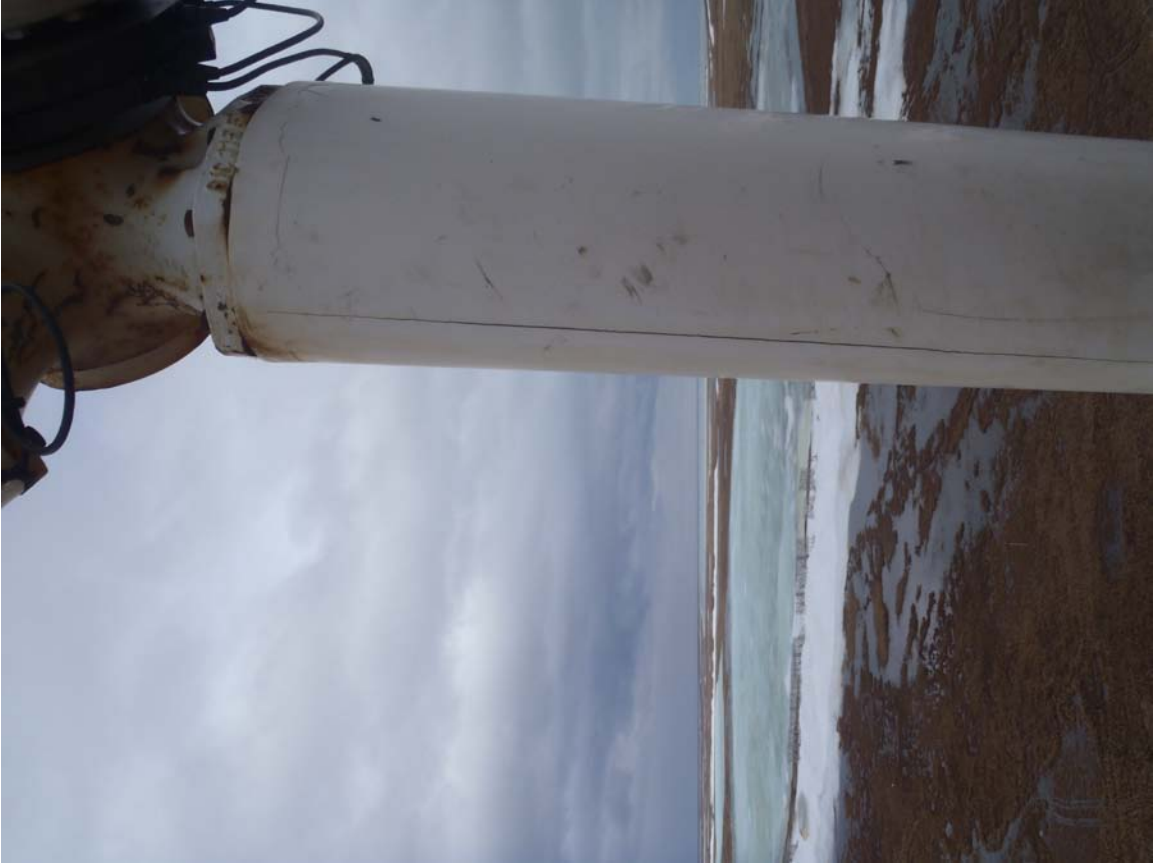
Picture 2: Blade Crack and Corrosion

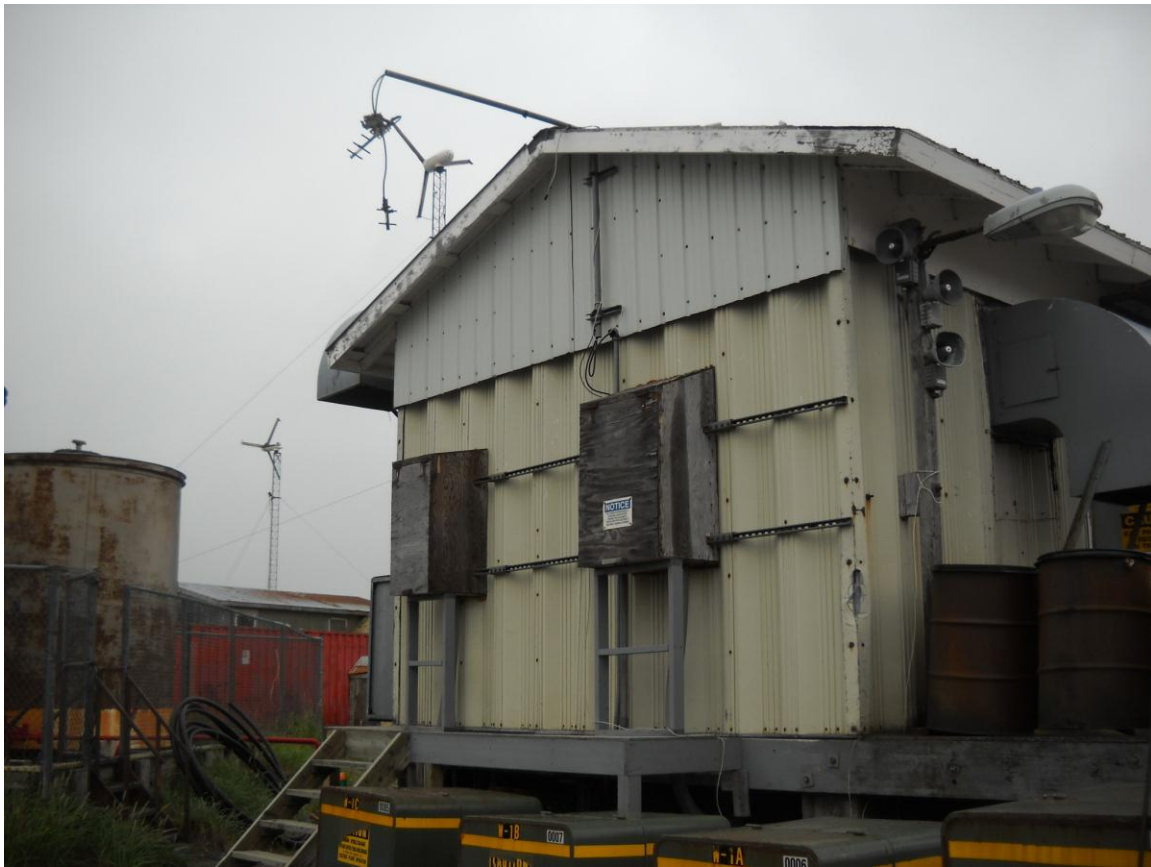
As reported last quarter the communication system (unexpected issues such as a revolving IP address system used by local telephone exchange) had severely limited the flow of information. Recently there has been damage to the communication antennae mast (shown in Picture 1, below). In order to avoid this in the future, a new piece of rigid conduit will be mounted as well as new yagi antennae and coax cables.

Picture 1: Damaged communication antennae mast

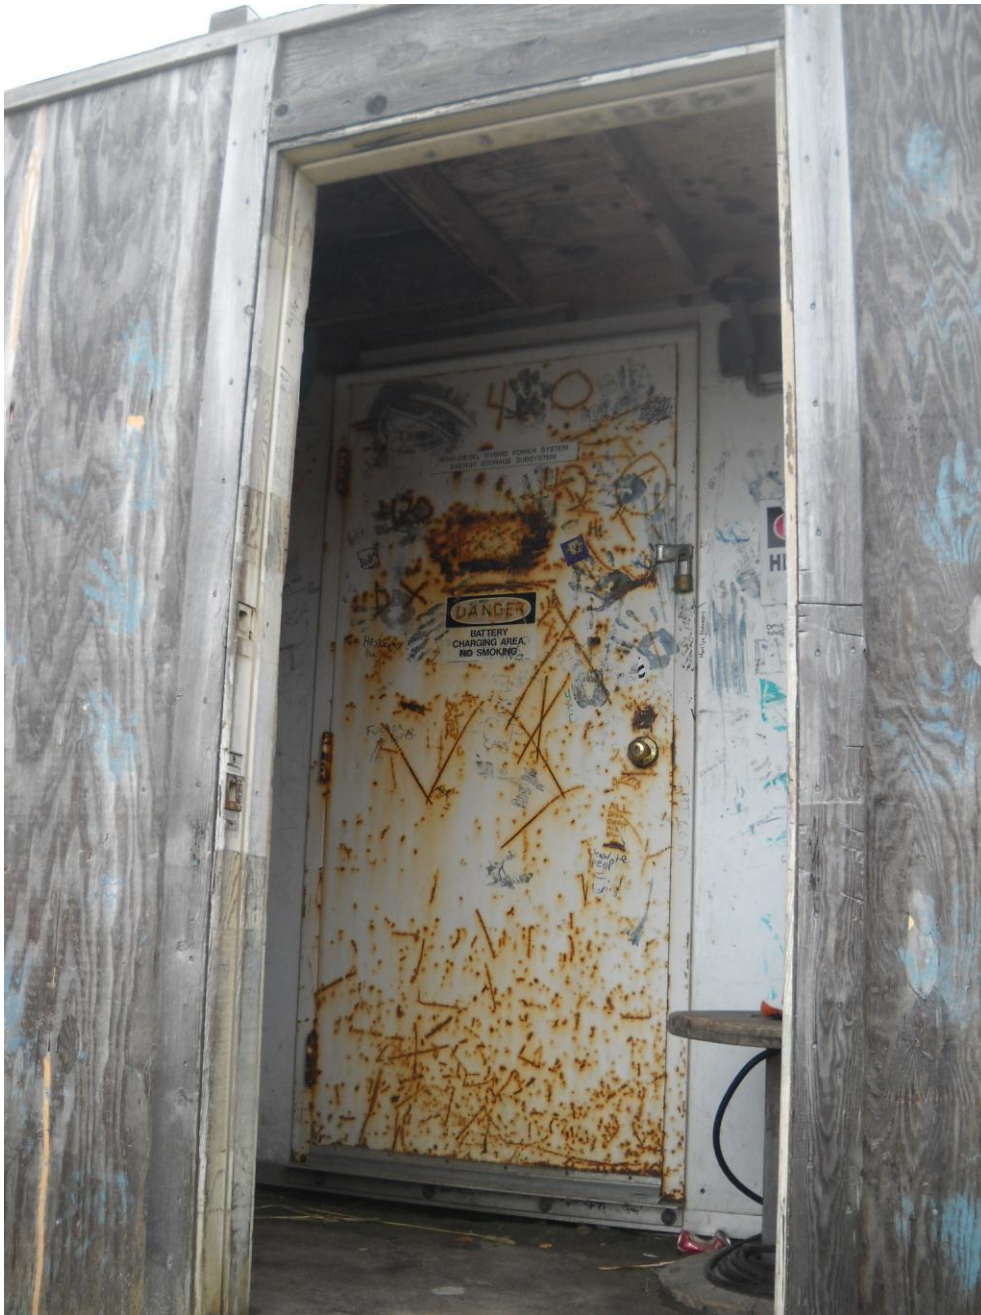
During the summer of 2011 a HughesNet dish was installed at the Wales facility to increase communication (see picture 2, below). There has also been some corrosion and apparent vandalism to the ESS (energy storage system) connex (see picture 3, below). A door will be fabricated to keep vandals away from the ESS entrance door. The door is meant to keep snow away from the ESS door that swings out of the ESS (for emergency egress purposes). A roof hatch is also mounted for emergency egress.

Picture 3: Corrosion and vandalism to ESS entrance.

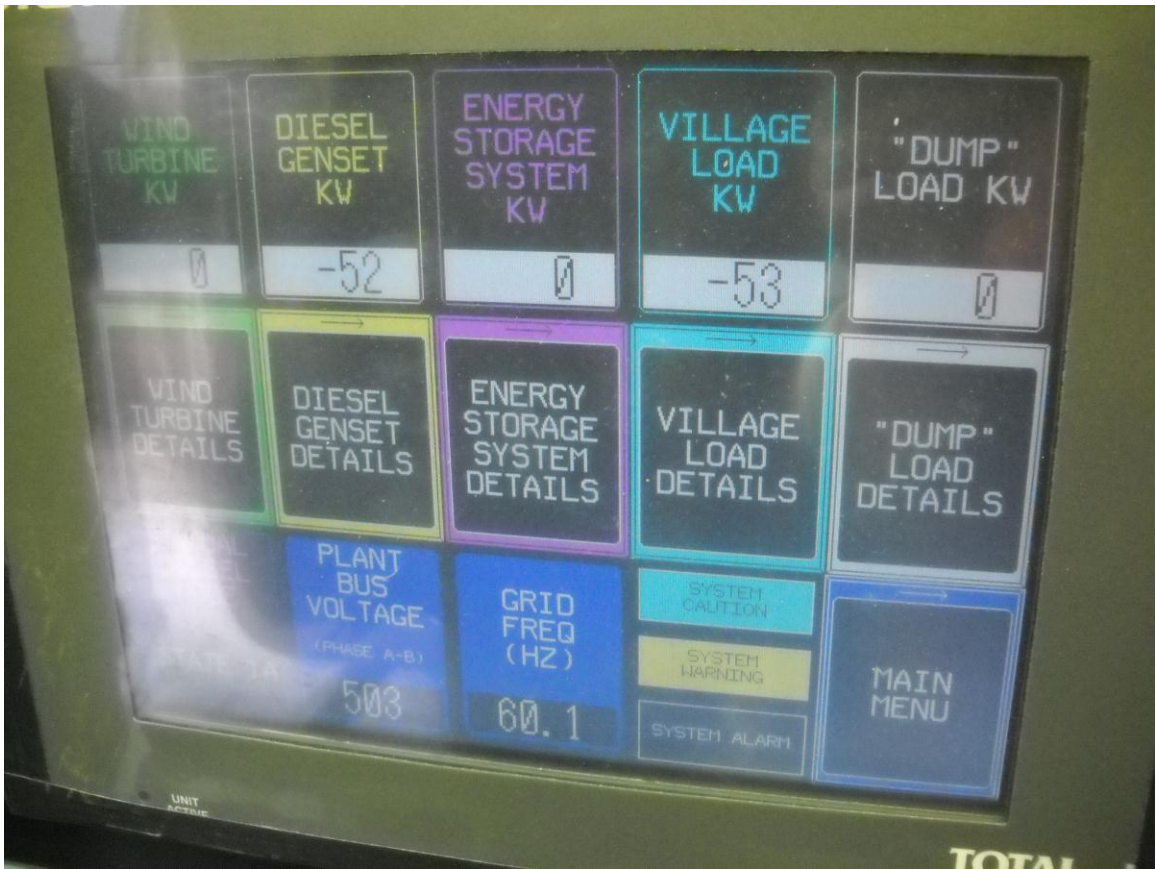
Electrical troubleshooting on the wind and ESS systems showed erroneous power readings (see picture 4, below). These erroneous power readings are possibly caused by new power measuring equipment that was added. The analog current output circuit of each engine power transducer will need to be traced out and verified to be supply power signals to both the new equipment and the WDCP PLC.

Picture 4: Erroneous electrical readings.
